# EO 30-001 Relocation of Wiper Switch

EC135 T3H/P3H

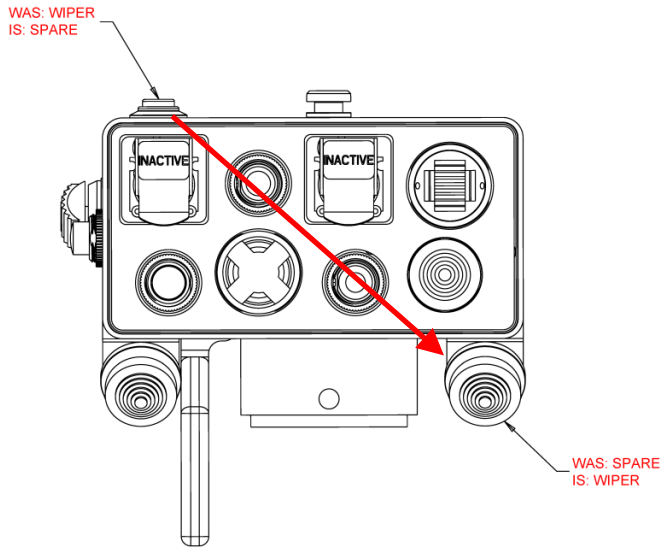
With this modification, the wiper switch on the PIC collective lever is relocated as shown in Fig. 1. This reduces the risk of an unintended activation of the windscreen wiper when the collective lever is fixed with its locking lug, as unintended activation in dry conditions causes scratches in the windscreen. The actual function and activation of the wiper is not changed. Pushing the 4-way toggle switch once in any position/direction causes one cycle of the windscreen wiper. The new switch is labelled for its intended function.

Fig. 1 – Relocation of wiper switch on PIC Collective Lever

There are no additional parts needed, the rewiring is accomplished according to a Wiring Diagram.
